# Investigations for Non-Stormwater Discharge

## Requirements, Site Evaluations, & Case Study

Presented by: Jimmy Greene  
Texas Regional Stormwater Conference 2026

# Case Study: Texas Facility

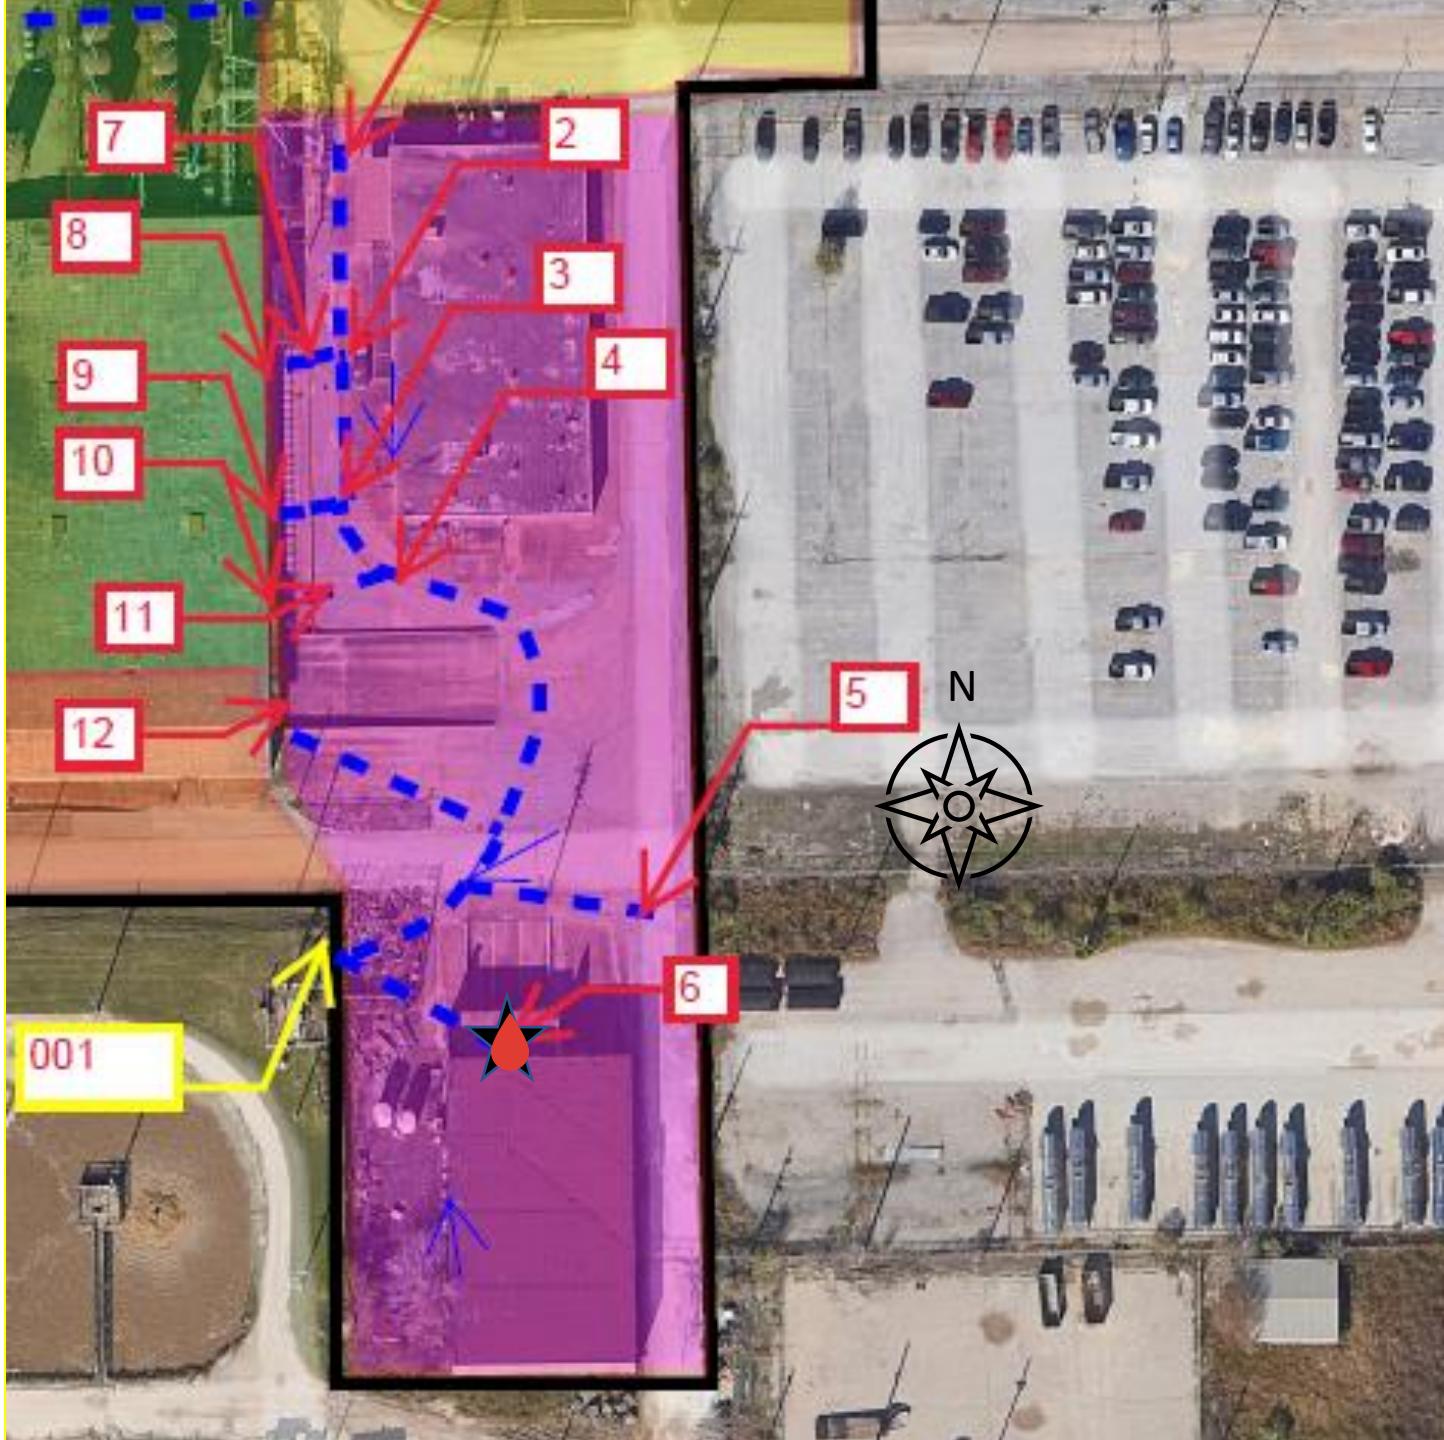
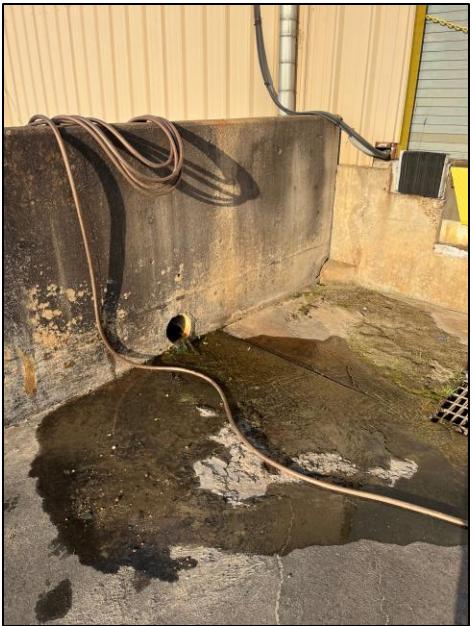
## Outfall 001

- Dye added to inlet 6 (Dock)
- Anticipated discharge at Outfall 001
- Released water into other dock by Inlet 12

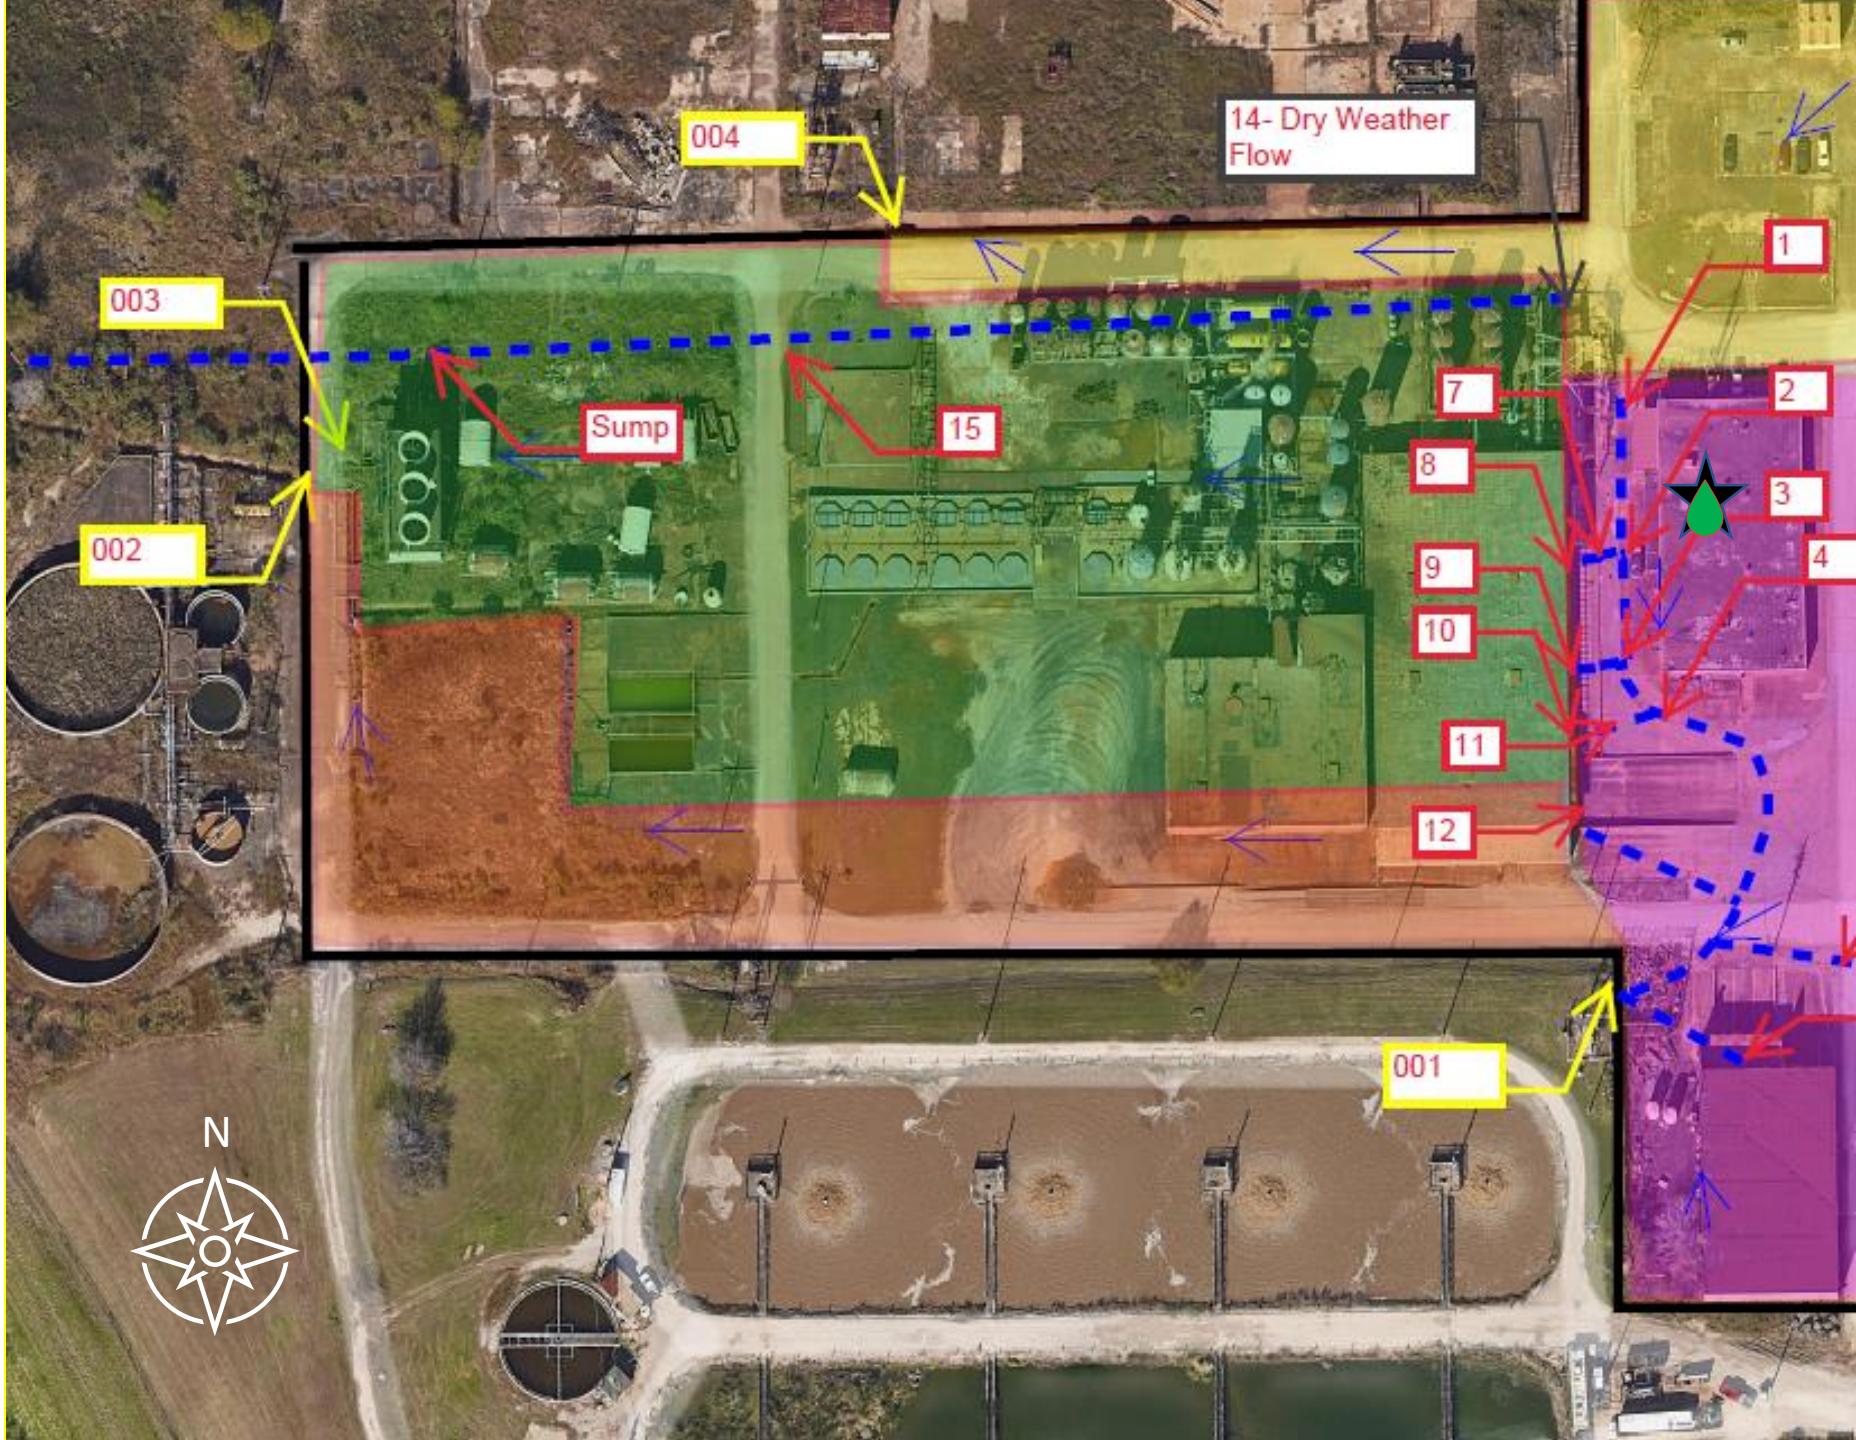
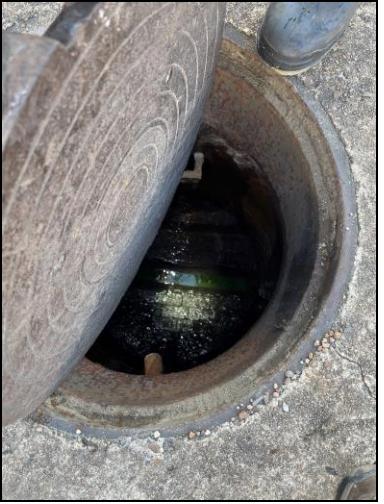
## Outfall 003

- Dye added to lab sink
- Checked if site contributing to dry weather flow
- Dye was visible in Sanitary Line
- Dry weather flow determined to be from offsite source

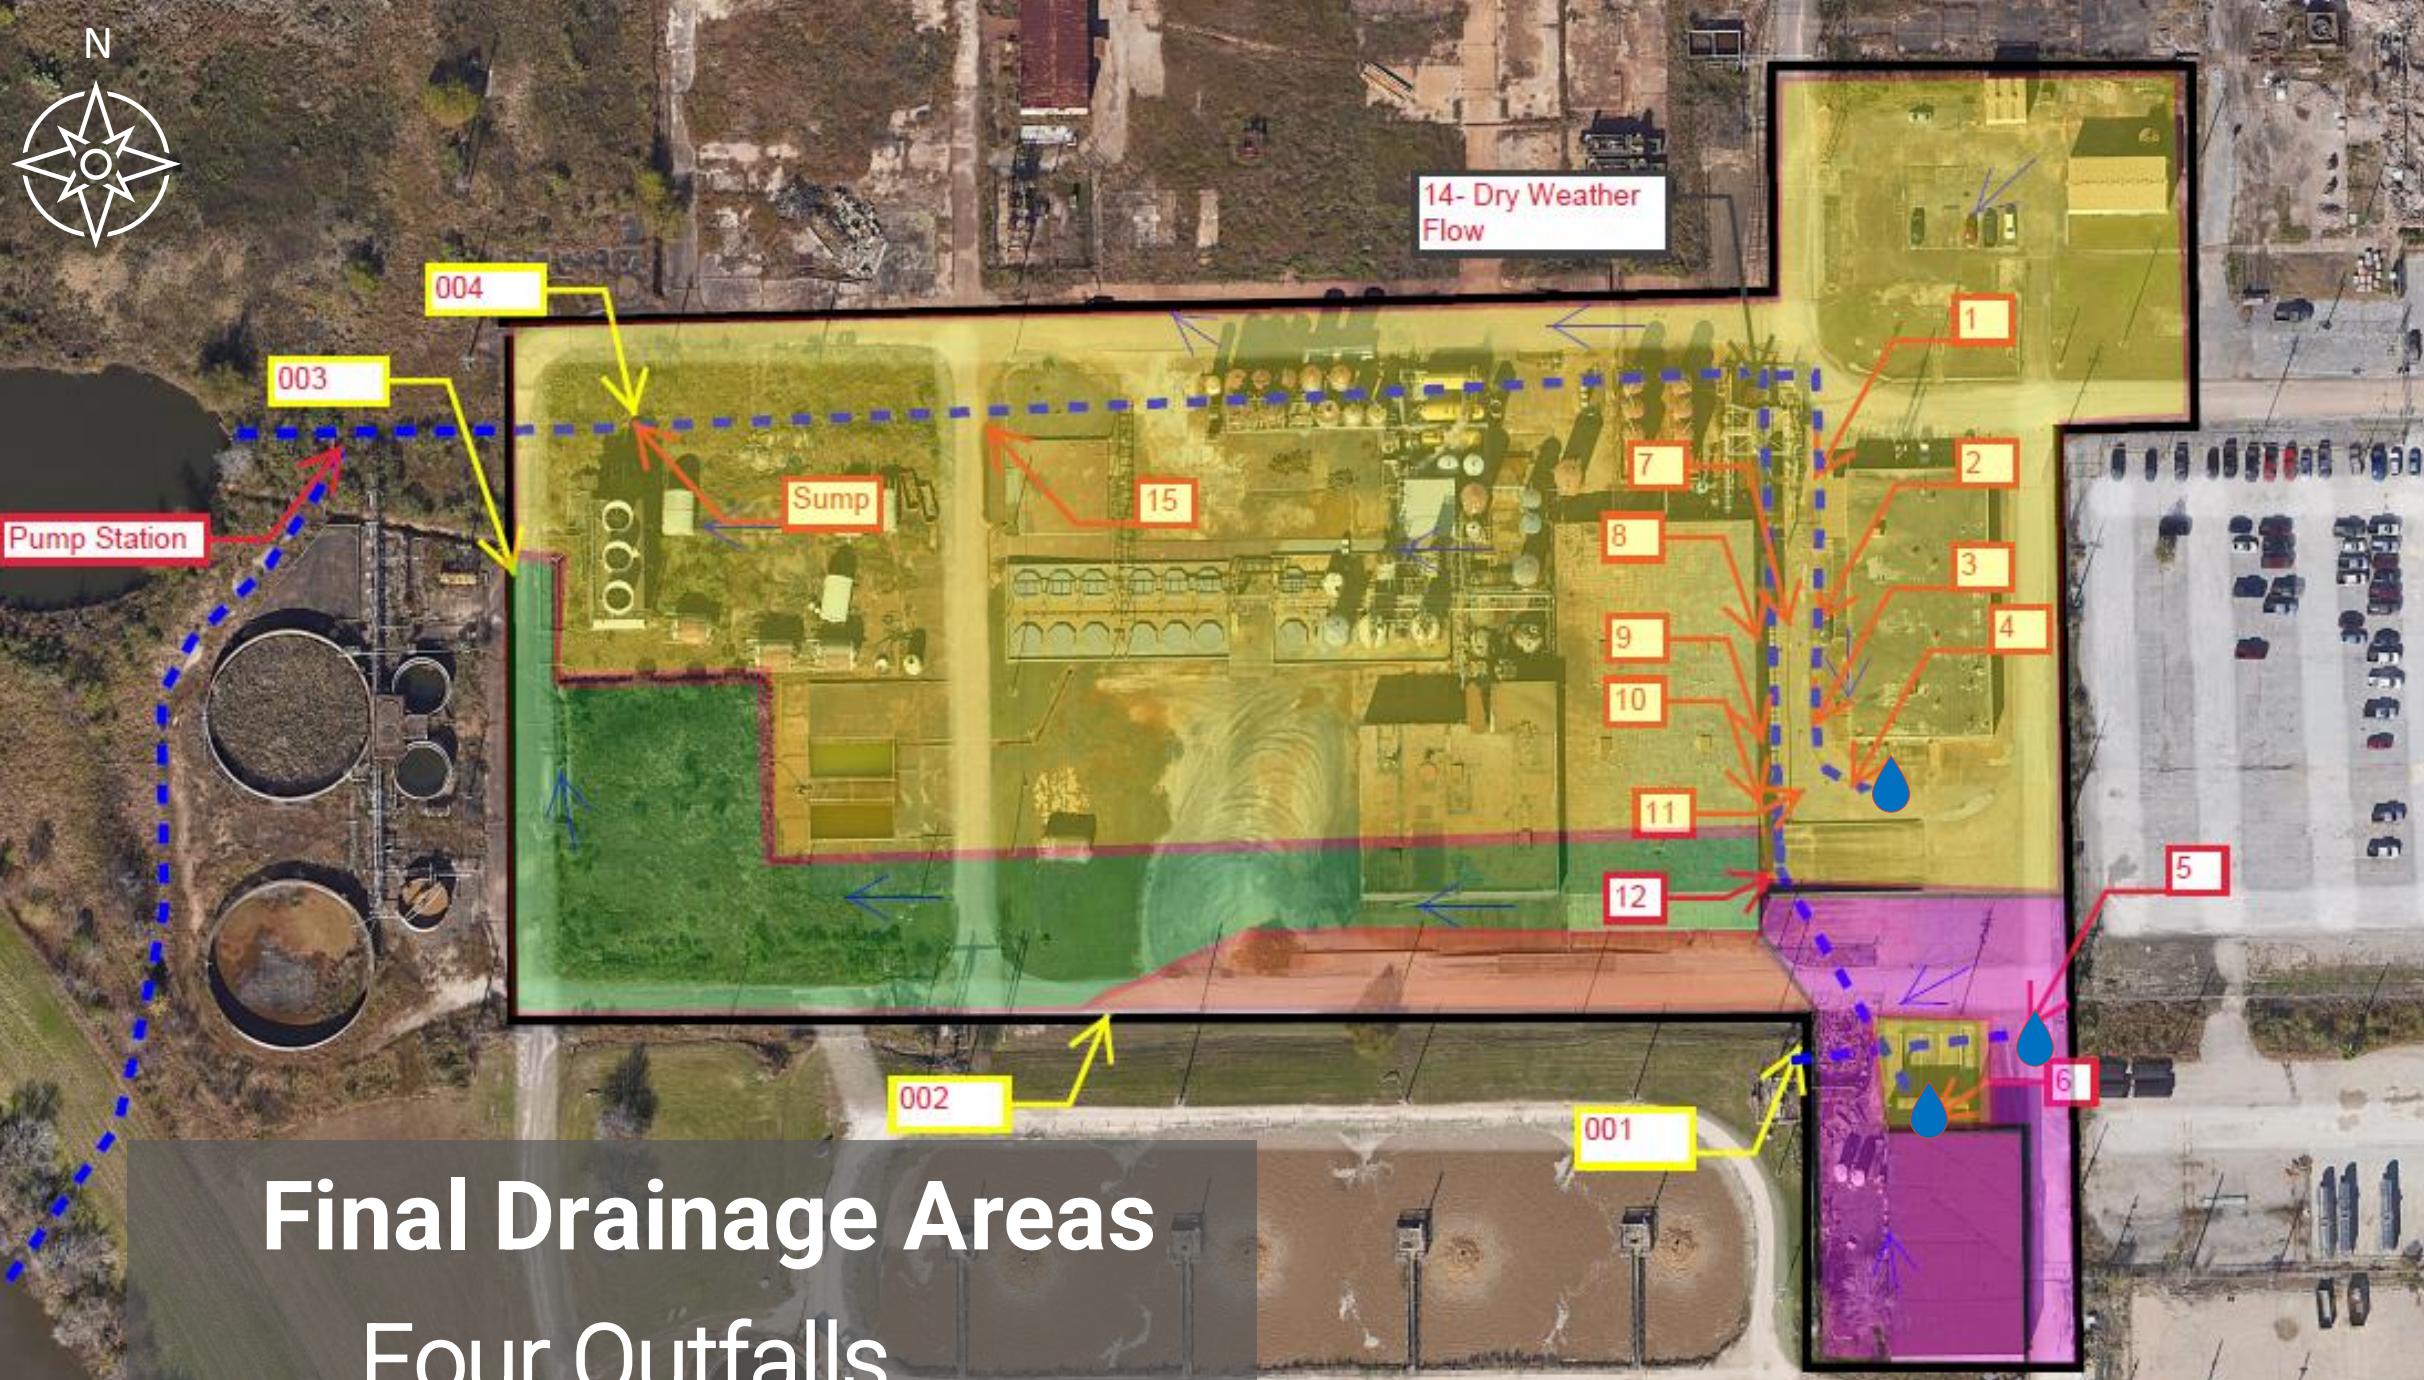
# Updated Map

- 4 Outfalls
- 7 sample points
- Avoids commingled water
- Dry weather flow is from neighboring facility
