Best Management Practice (BMP) Maintenance Requirements to Ensure Protection of Edwards Aquifer Water Quality

Project Goals

1. Assess the maintenance status for BMPs in the Edwards Aquifer contributing zone within Bexar County, Texas
2. Identify the differences between the three BMP types in treating pollutants before and after maintenance
3. Conduct a life cycle analysis to interpret the significance of the results on each BMP's:
 - a. Treatment efficacy
 - b. Costs
 - c. Waste streams

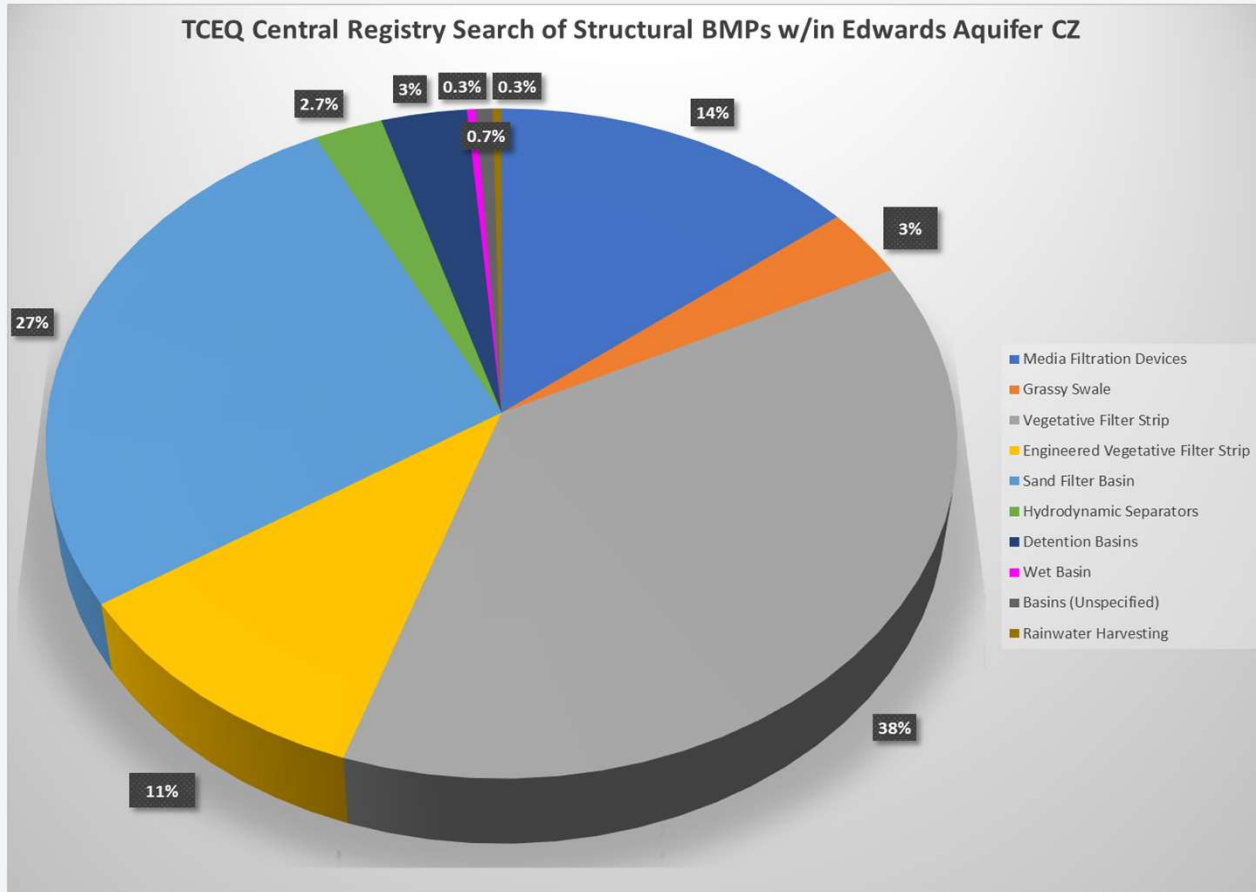
TCEQ BMPs

- TCEQ Registry Search
 - BMP total: 301
- SAWS Database Search
 - BMP total: 208
- Noncompliance
 - Varying issues from 2017-2022
 - 124 different BMPs documented 329 times for initial noncompliance and continued noncompliance at follow-up

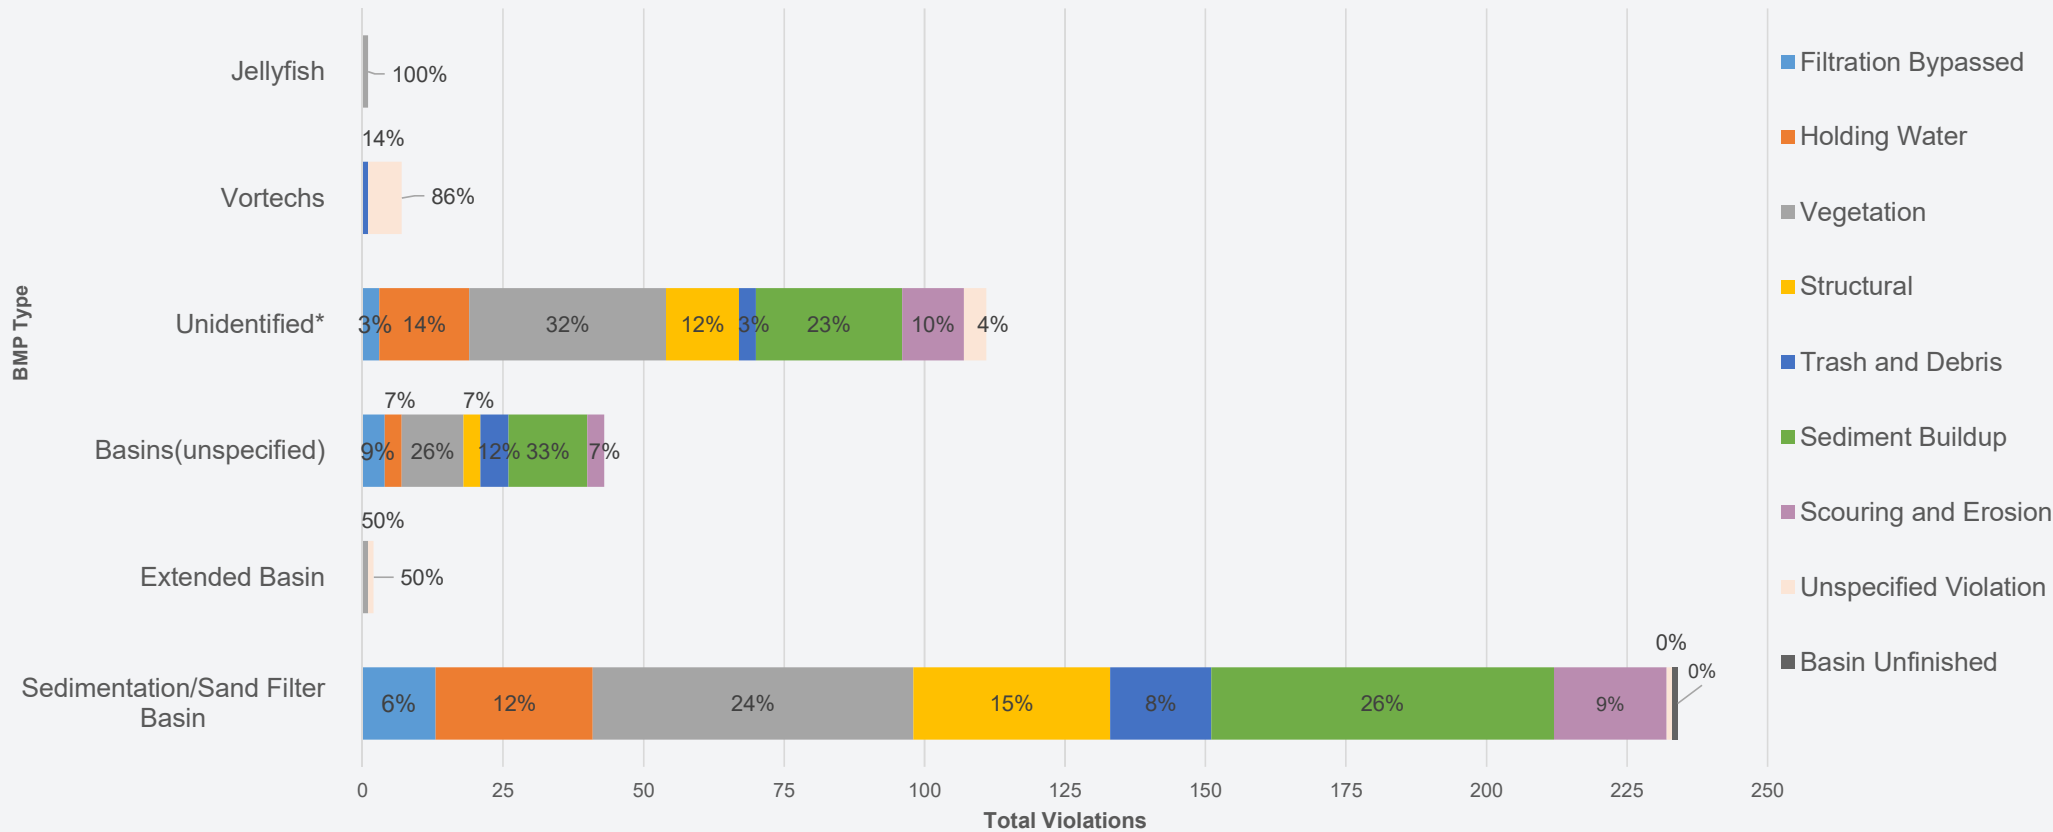
SAWS Noncompliance – Excludes Vegetative BMPS

*BMP type is not identified in database

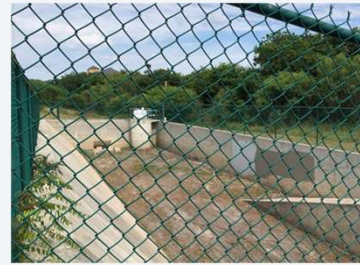
Sand Filter Basin

Sand Filter Basin- UTEX Blvd

- Business development over contributing zone
- Various BMPs providing treatment to overall development area
 - Jellyfish, vegetative filter strip
- Treatment area
 - 8.19- acre drainage basin area

- Sand filter basin continued to meet solids removal efficiency (89%) over the pre-maintenance monitoring period
- Compliance issues found in 60% of BMPs in database
 - Vegetative overgrowth
 - Sediment buildup

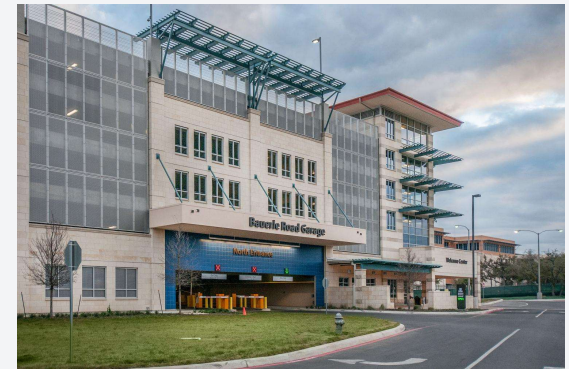
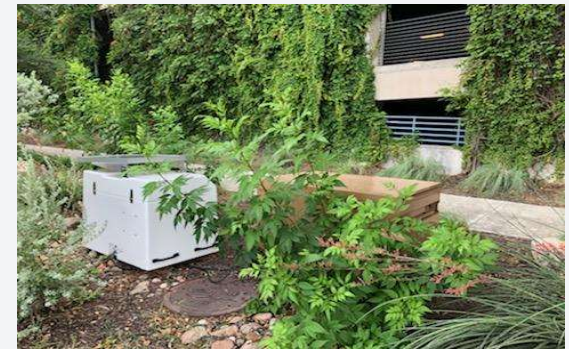
Vortechs- Bauerle Rd. Garage

- Vortechs hydrodynamic separator
- UTSA Parking Garage
 - Includes a pedestrian bridge and Welcome Center
- Treatment area
 - 0.92- acre area of the garage rooftop

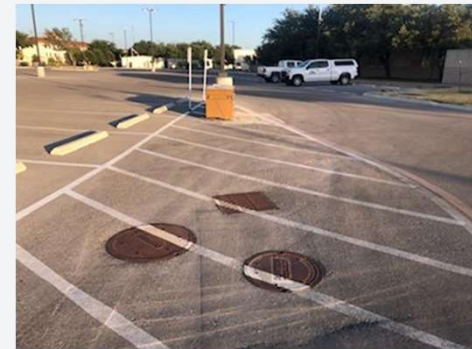
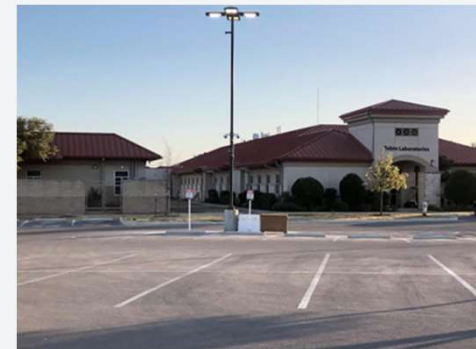
Jellyfish- UTSA Resident 5 Lot

- Jellyfish Filter – Overdue for maintenance
- Surface lot located on the UTSA campus
- Treatment area
 - 1.83-acre drainage area

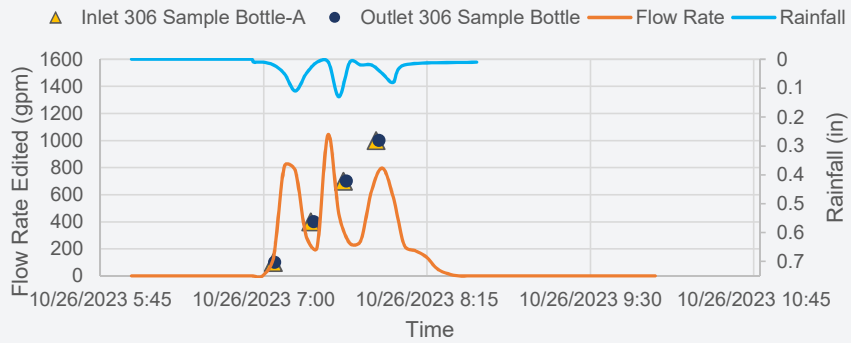
Jellyfish 10/26/2023

Hydrographs - Jellyfish: Pre-maintenance
